Shipping Australia Limited
ABN 61 096 012 574

Level 1, 101 Sussex Street, Sydney NSW 2000
PO Box Q388 QVB PO, Sydney NSW 1230

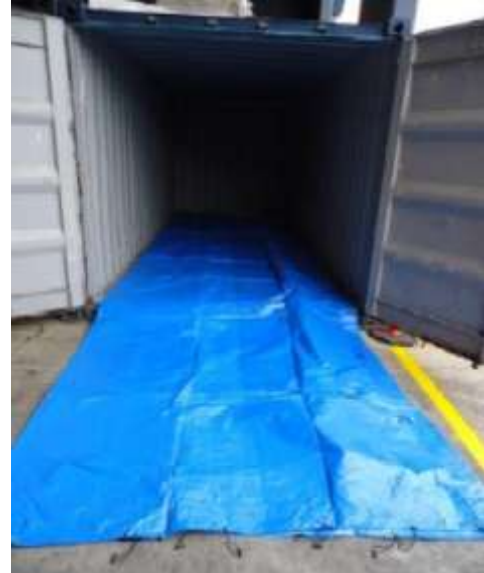
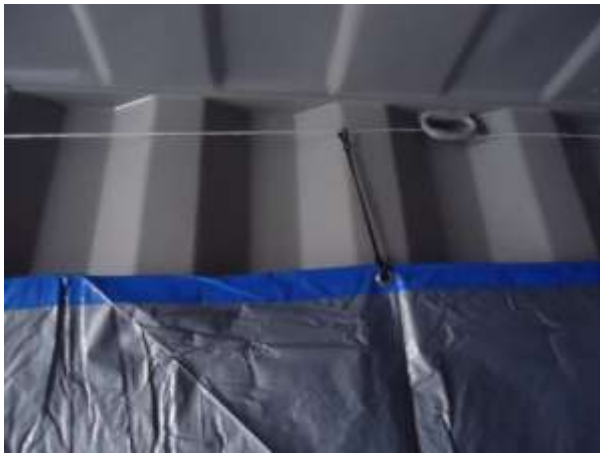
To establish a fixing point for the liner a bail lash or 4mm rope is run through the lashing points around the top of the container and tied off ensuring that the lash is tight.

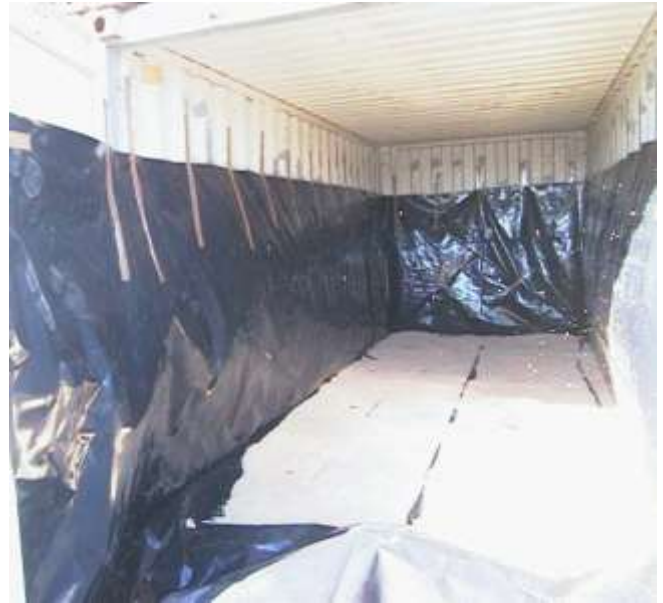
Note: It is recommended that liners and absorbent medium be supplied and fitted by a depot/packing warehouse that has previous experience in carrying out this task.
